Summary of EPA Surface Water Sampling of Select Metals Results to Date

Gold King Mine Blowout

August 7, 2015

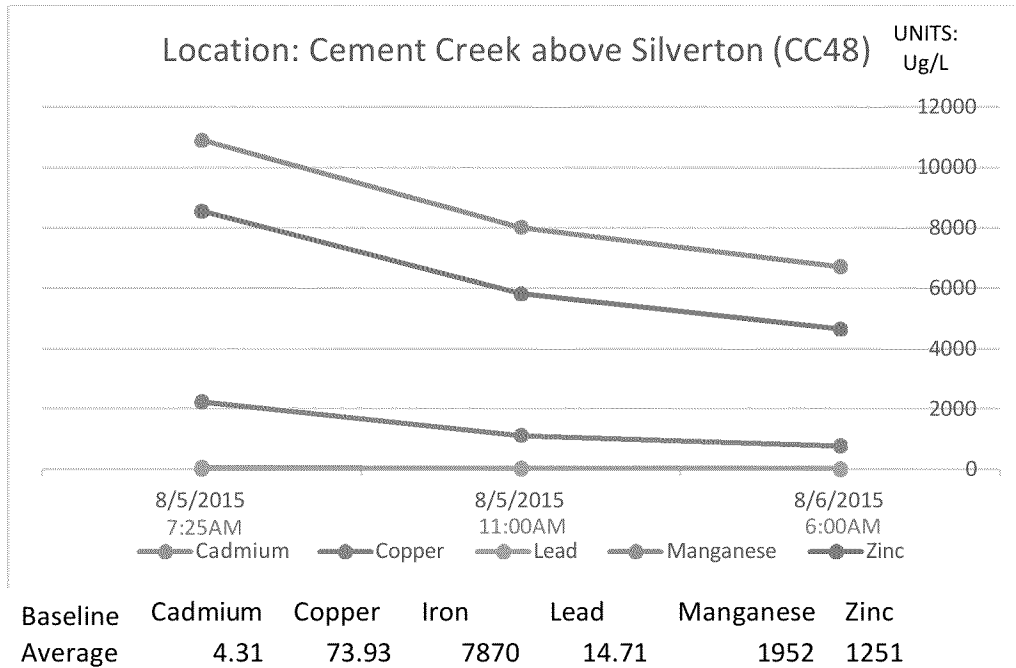
The first graph provides data on Cement Creek, the downstream from the blowout (CC48). Concentrations throughout the first day following the blowout are above historical averages for the copper, lead and manganese. However, the graphs demonstrate a decrease in those concentrations over the 24 hour period.

The graphs in Attachment 2 demonstrate trends in concentrations of select metals that have been detected historically in both Cement Creek and the Animas River. Each graph represents the trends in those concentrations between August 5, and August 6, 2015. Each graph also provides the average historical (pre-blowout) concentration of those metals. Historical concentrations are not available for the 32nd Street Bridge location. The blowout occurred late in the morning on August 5, 2015. The contaminant plume moved down stream at approximately 4 miles per hour. The trends over time and location represent the movement of the contamination and the return of the Animas River to conditions before the event.

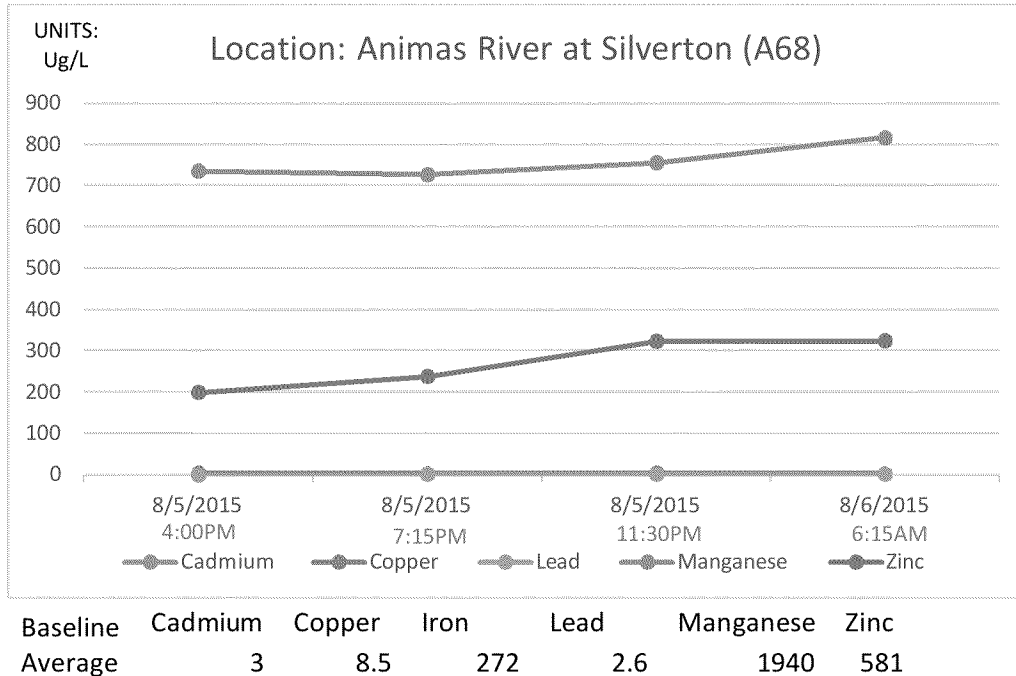
The second graph provides data on the Animas River above the town of Silverton (A68) and above Cement Creek. This graph demonstrates relatively unchanging metals concentrations that are at or below historical averages.
